**Flood Control Project Maintenance
Levee Inspections**
LMA District Cover Sheet
Spring 2018 Levee Inspection Results

Reclamation District No. 0150 Merrit Island

Spring 2018 Levee Inspection Results

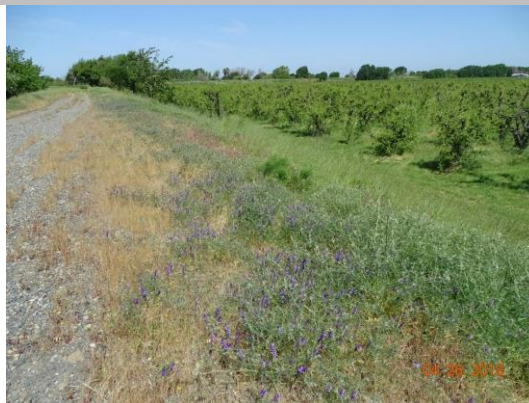
Photo 1 of 1 : SP_2018_RD0150_15_1_20180430_00003.jpg

LM Start	0.17	Rating **	M	Issue No.	1
LM End	0.17	Issue Type +	Ma	Location *	LS
Category	Earthen Levee			GPS Latitude/Longitude	
				Start	End
Item	Vegetation			38.331620 °	38.331620 °
				-121.580736 °	-121.580736 °
DWR ID	DWR_RD0150_01_s_2018_1				
Comment Code					
V1 : Control annual grass and weeds on the levee slopes and easements.					
Inspector Comment

Vegetation landside looking west.

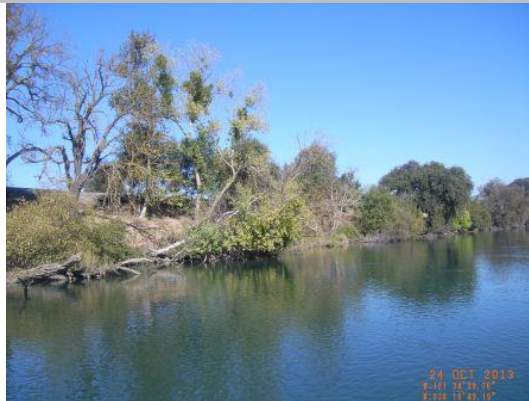
Photo 2 of 2 : SP_2018_RD0150_15_2_20180301_00002.jpg

LM Start	0.44	Rating **	M	Issue No.	2 (cont)	
LM End	0.49	Issue Type +	Ma	Location *	WS	
Category	Supplemental			GPS Latitude/Longitude		
				Start		End
Item	2015 USACE Erosion Survey, DRAFT			38.328555 °		38.328020 °
				-121.577544 °		-121.576693 °
DWR ID	DWR_RD0150_01_s_2016_2					
Comment Code						
Inspector Comment						
2013 - Old toe repair unraveling. Bridge at upstream end of site. 2015: No observed changes. [2015 Site ID: STR_28-4_R]

USACE 2013 Photo #2

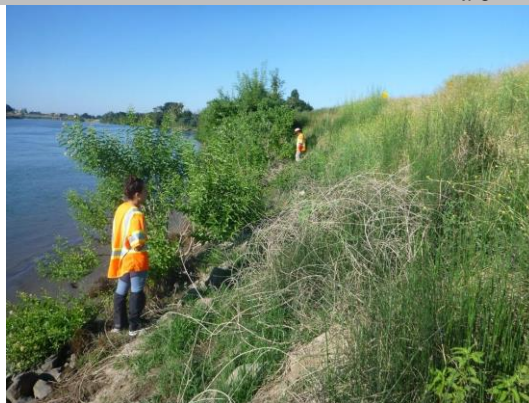
Photo 1 of 3 : LEVAL_SP_2018_286_1942.jpg

LM Start	0.11	Rating **	A/W	Issue No.	46
LM End	0.14	Issue Type +	Ma	Location *	
Category	Supplemental			GPS Latitude/Longitude	
				Start	End
Item	2017 Storm Damage			38.329369 °	38.329767 °
				-121.574936 °	-121.574589 °
DWR ID	DWR_RD0150_02_f_2017_46				
Comment Code					
Inspector Comment					
Levee Evaluation Comments					
Description:The flood damage consists of a waterside erosion approximately 185 feet long on the west (right) bank of the Sacramento River. See attached pages for photos.					
Site ID No:286					
Site Designation:LMA-112					
Repair Type: Erosion					
Rating:Area of Concern					
Field Date:7/17/2017					
Notes: Crown is a paved road. Scarps upto 3 ft deep, not fully vertical though. Area of concern because erosion is not very deep into prism.

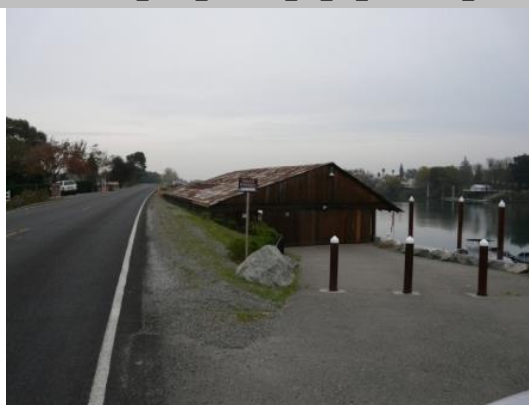
Photo 1 of 1 : SP_2018_RD0150_16_49_20180301_00027.jpg

LM Start	0.16	Rating **	U	Issue No.	49
LM End	0.16	Issue Type +	En	Location *	WS
Category	Earthen Levee			GPS Latitude/Longitude	
				Start	End
Item	Encroachments			38.330047 °	38.330047 °
				-121.574538 °	-121.574538 °
DWR ID	DWR_RD0150_02_s_2012_49				
Comment Code					
BU : Building					
Inspector Comment

Building located on waterside of levee.

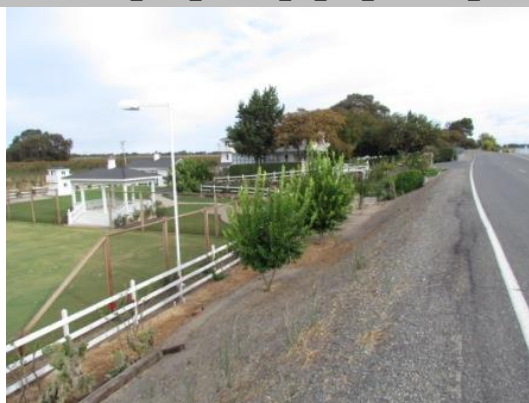
Photo 1 of 1 : SP_2018_RD0150_16_990_20180301_00068.jpg

LM Start	0.17	Rating **	M	Issue No.	990
LM End	0.21	Issue Type +	En	Location *	LS
Category	Earthen Levee			GPS Latitude/Longitude	
				Start	End
Item	Vegetation			38.330173 °	38.330576 °
				-121.574490 °	-121.574093 °
DWR ID	DWR_RD0150_02_s_2012_990				
Comment Code					
V6 : Landscaping					
Inspector Comment

Landscaping was found on the landside of the levee looking upstream.

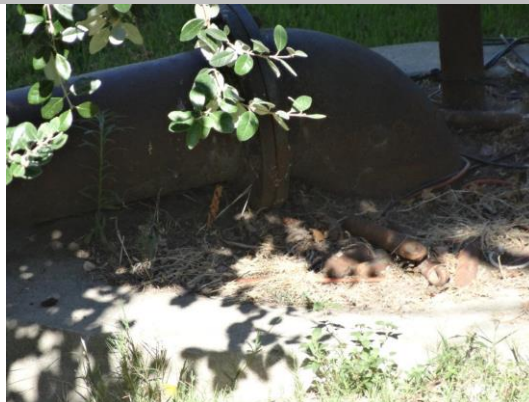
Photo 3 of 3 : UCIP_SP_2018_42700_34245.jpg

LM Start	0.23	Rating **	M	Issue No.	991 (cont)	
LM End	0.23	Issue Type +	En	Location *		
Category	Supplemental			GPS Latitude/Longitude		
				Start		End
Item	DWR UCIP Field Study			38.330888 °		38.330888 °
				-121.573769 °		-121.573769 °
DWR ID						
Comment Code						
Inspector Comment						
FS_ID:42700 DS_ID:22416 EP_NO: N/A Repair Type: Non-Urgent Crossing Status: Found UCIP Comments: Appears abandoned and if so should be done so properly.- Dense vegetation on waterside.- Seems abandoned pipe and pump. FIELD_STRUCT_DESC: *ABANDONED* 10-inch steel irrigation discharge pipe through the levee, invert elevation 2.8 feet below the crown. Pump on the landside (LS). Concrete box on the LS. (Thomas Estate). [Additional Reference(s): DWR Levee Log, 2005. USACE Sacramento O&M Manual 112, March 1957, (RM 34.23)]. FS Date: 8/27/2013

LS view: abandoned pipe and concrete box on landside toe.

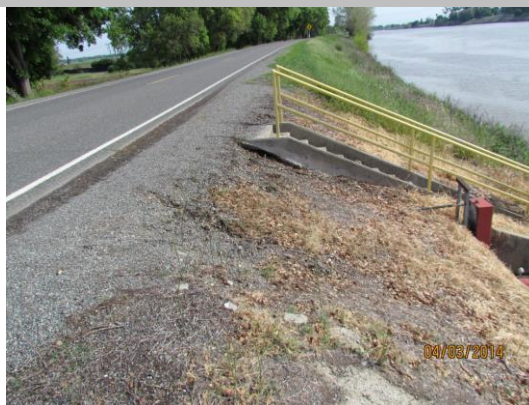
Photo 2 of 2 : SP_2018_RD0150_16_6_20180301_00004.jpg

LM Start	0.38	Rating **	M	Issue No.	6
LM End	0.38	Issue Type +	Ma	Location *	WS
Category	Earthen Levee			GPS Latitude/Longitude	
				Start	End
Item	Slope Stability			38.332598 °	38.332598 °
				-121.572179 °	-121.572179 °
DWR ID	DWR_RD0150_02_s_2012_6				
Comment Code					
S2 : Repair the levee slope damaged by foot traffic and prevent access where possible.					
Inspector Comment

Updated photo of the slope instability on the waterside of the levee looking upstream during spring 2014 inspection.

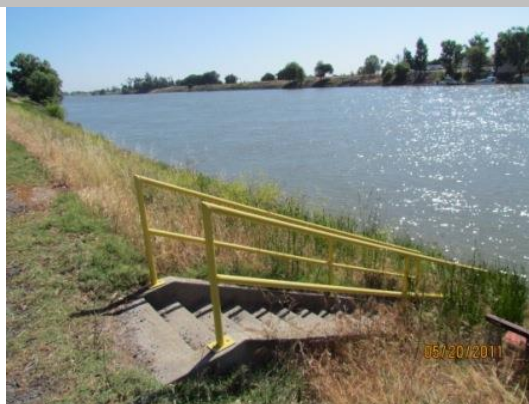
Photo 1 of 1 : SP_2018_RD0150_16_13_20180301_00008.jpg

LM Start	0.38	Rating **	M	Issue No.	13
LM End	0.38	Issue Type +	En	Location *	WS
Category	Earthen Levee			GPS Latitude/Longitude	
				Start	End
Item	Encroachments			38.332647 °	38.332647 °
				-121.572140 °	-121.572140 °
DWR ID	DWR_RD0150_02_s_2012_13				
Comment Code					
ST : Stairway					
Inspector Comment

A stairway was found on the waterside of the levee. The picture was taken from the crown looking upstream.

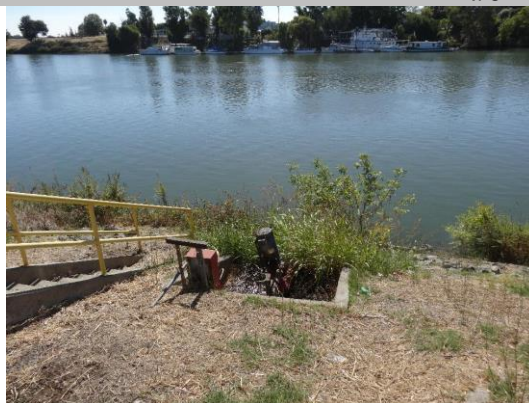
Photo 1 of 3 : UCIP_SP_2018_20268_34244.jpg

Comment Code						
Inspector Comment						
FS_ID:20268						
DS_ID:22417						
EP_NO: N/A						
Repair Type: Non-Urgent						
Crossing Status: Found						
UCIP Comments: - Water leaks from pressure breaker.- Distribution box at the landward toe not found/visible.- Service pole on LS toe.						
FIELD_STRUCT_DESC: 4-inch steel irrigation discharge pipe joined to a 6-inch steel irrigation discharge pipe which is in turn joined to a 10-inch steel irrigation discharge pipe through the levee, 5.8 feet below the crown. 1.5-inch electrical conduit through the levee, 3 feet below the crown. Pump and gate valve on the waterside (WS) slope. (Retention of an irrigation pumping plant, centrifugal pump, and gate valve on the WS levee slope with a 10-inch pipe through the levee authorized under Permit No. 9448, 1974 - William N. Runyon). [Additional Reference(s): DWR Levee Log, 2005].						
FS Date: 8/27/2013

WS view: walkway/stairs, pump on levee slope.

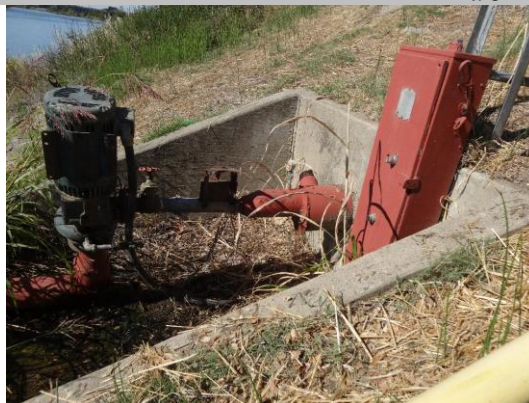
Photo 2 of 3 : UCIP_SP_2018_20268_34243.jpg

WS view: pump, electric control box, electric conduit on concrete pad.
Water leaks from pressure breaker.

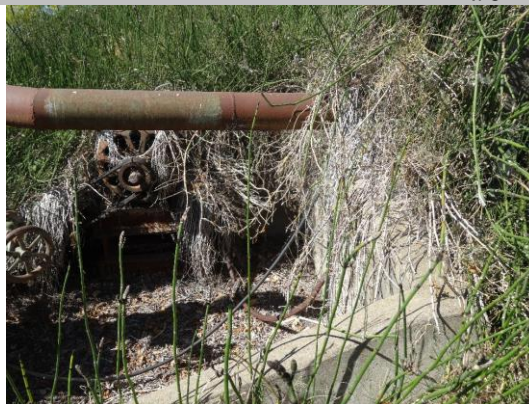
Photo 2 of 3 : UCIP_SP_2018_20267_34238.jpg

Comment Code					
Inspector Comment					
FS_ID:20267 DS_ID:22418 EP_NO: N/A Repair Type: Non-Urgent Crossing Status: Found UCIP Comments: - Abandoned pipe and pump.- Needs proper abandonment. FIELD_STRUCT_DESC: 6-inch steel irrigation discharge pipe and a 1-inch electrical conduit through the levee, invert elevation 3.5 feet below the crown. Pump and gate valve on the waterside (WS) slope. Electrical box on the WS slope. (Retention of an irrigation pumping plant, centrifugal pump, and gate valve on the WS with a 6-inch pipe through the levee authorized under Permit No. 9447, 1974 - Reuben A. Gentner). [Additional Reference(s): DWR Levee Log, 2005. USACE Sacramento O&M Manual 112, March 1957, (RM 34.47)]. FS Date: 8/27/2013

WS view: steel pipe and pump on concrete pad. Seems abandoned.

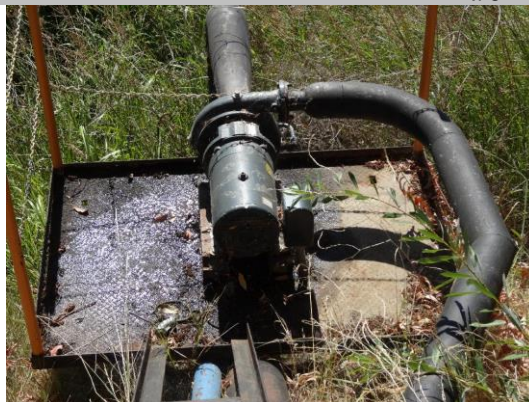
Photo 2 of 3 : UCIP_SP_2018_20303_34286.jpg

Comment Code					
Inspector Comment					
FS_ID:20303 DS_ID:22421 EP_NO: 16109 Repair Type: Non-Urgent Crossing Status: Found UCIP Comments: - 10" steel pipe on both sides of the levee. According to permit and inspectors note- 16" steel pipe through the levee.- concrete standpipe inside water filtration plant on landside toe.- air pressure tank on waterside steel deck. FIELD_STRUCT_DESC: 16-inch wrapped steel irrigation discharge pipe and a 2-inch electrical conduit through the levee, invert elevation 6.2 feet below the crown. Slant pump on a steel platform on the waterside (WS) slope. 4-inch abandoned pipe on the WS slope. Concrete standpipe and power pole at the landside (LS) toe. (Plans to replace an existing irrigation pipe with a 16-inch wrapped steel pipe through the levee, construct a 3-foot-square concrete anchorage block on the WS slope, and install a 2-inch utility pipe through the levee authorized under Permit No. 18258-Revised, 2007 - Wilson Farms, Inc). [Additional Reference(s): DWR Levee Log, 2005, 14-inch pipe referenced. USACE Sacramento O&M Manual 112, March 1957, (RM 34.71), 14-inch pipe referenced]. FS Date: 8/27/2013

WS view: steel pipes and leaky slant pump on steel deck.

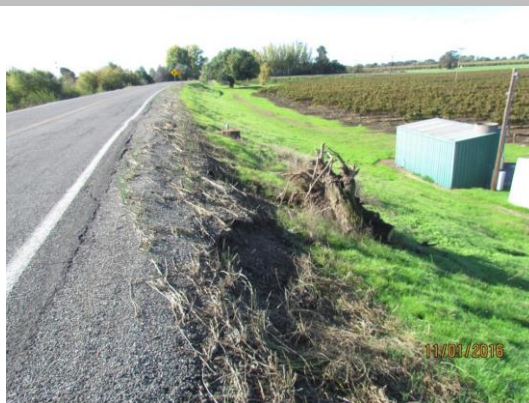
Photo 2 of 2 : SP_2018_RD0150_16_59_20180301_00042.jpg

LM Start	0.71	Rating **	M	Issue No.	59
LM End	0.71	Issue Type +	Ma	Location *	LS
Category	Earthen Levee			GPS Latitude/Longitude	
				Start	End
Item	Encroachments			38.336291 °	38.336291 °
				-121.568260 °	-121.568260 °
DWR ID	DWR_RD0150_02_s_2016_59				
Comment Code					
TR : Tree or limb					
Inspector Comment					
Damaged tree roots and trunks appear to damage landside slope of the levee.

Updated picture of the tree limbs and roots on the landside of the levee looking downstream. Fall 2016

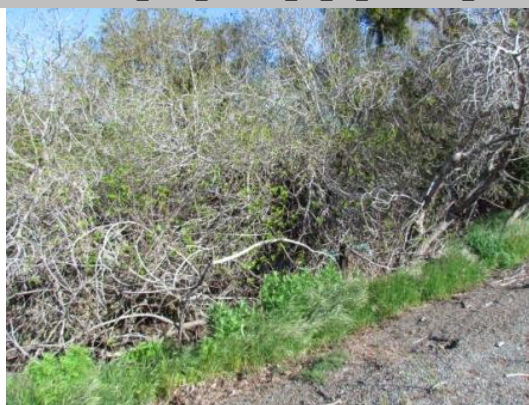
Photo 1 of 1 : SP_2018_RD0150_16_12_20180301_00007.jpg

LM Start	0.97	Rating **	M	Issue No.	12
LM End	0.97	Issue Type +	En	Location *	LS
Category	Earthen Levee			GPS Latitude/Longitude	
				Start	End
Item	Encroachments			38.339035 °	38.339035 °
				-121.565145 °	-121.565145 °
DWR ID	DWR_RD0150_02_s_2012_12				
Comment Code					
TR : Tree or limb					
Inspector Comment

Overgrown trees were obstructing the landside slope of the levee looking upstream.

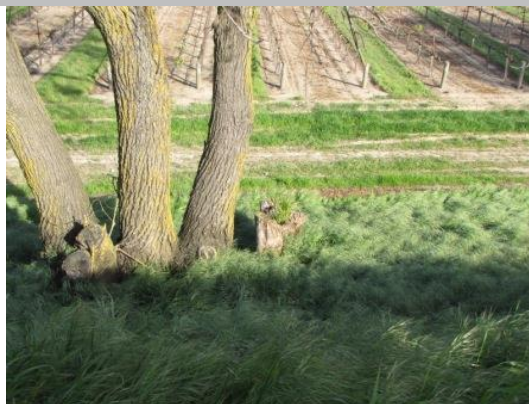
Photo 1 of 1 : SP_2018_RD0150_16_8_20180301_00005.jpg

LM Start	1.14	Rating **	N	Issue No.	8	
LM End	1.14	Issue Type +	Ma	Location *	LS	
Category	Earthen Levee			GPS Latitude/Longitude		
				Start		End
Item	Trim / Thin Trees			38.340864 °		38.340864 °
				-121.562915 °		-121.562915 °
DWR ID	DWR_RD0150_02_s_2012_8					
Comment Code						
T5 : Tree stumps.						
Inspector Comment

View of a tree stump on the landward slope.

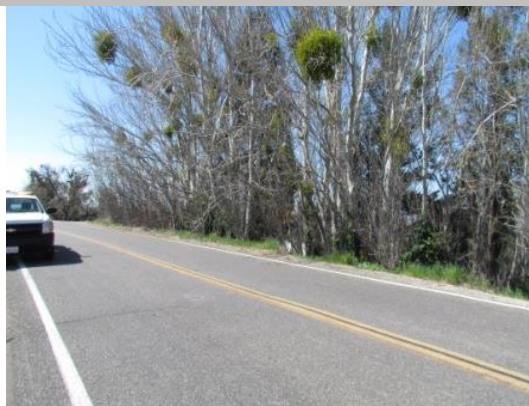
Photo 1 of 2 : SP_2018_RD0150_16_91_20180301_00058.jpg

LM Start	1.32	Rating **	U	Issue No.	91
LM End	1.35	Issue Type +	En	Location *	LS
Category	Earthen Levee			GPS Latitude/Longitude	
				Start	End
Item	Vegetation			38.343010 °	38.343276 °
				-121.561096 °	-121.560739 °
DWR ID	DWR_RD0150_02_s_2012_91				
Comment Code					
V6 : Landscaping					
Inspector Comment

Landscaping was obstructing the view of the landside slope of the levee looking downstream. This picture was taken during spring 2013 inspection.

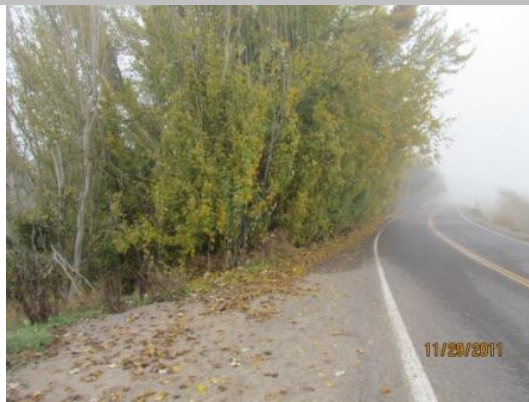
Photo 2 of 2 : SP_2018_RD0150_16_91_20180301_00059.jpg

Landscaping was found landside of the levee looking upstream.

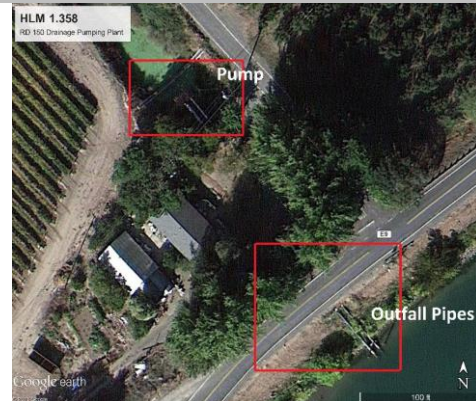
Photo 1 of 3 : UCIP_SP_2018_20727_34889.jpg

Bird's eye view: outfall pipes (bottom) and pump structure in drainage ditch (top)

Comment Code						
Inspector Comment						
FS_ID:20727 DS_ID:22393 EP_NO: 18221 Repair Type: Non-Urgent Crossing Status: Found UCIP Comments: Pump house and drainage ditch about 250 feet from the levee on landside.Pumps on piling structure with shed in drainage ditch.Siphon breaker cover missing. Needs to fix it. FIELD_STRUCT_DESC: [Reclamation District No. 150 (RD0150) Drainage Plant] 1 of 2: 30-inch steel drainage discharge pipe through the levee, 7 feet below the crown. Flap gate on the waterside (WS) end. Siphon breaker on the WS slope. Pump on a piling structure with a shed in the drainage ditch. (Plans to replace existing 36-inch and 24-inch discharge pipes with 30-inch and 24-inch steel discharge pipes through the levee authorized under Permit No. 18221, 2007 - RD0150). [Additional Reference(s): DWR Levee Log, 2005, 36-inch pipe referenced, 9 feet below the crown. USACE Sacramento O&M Manual 112, March 1957, (RM 35.36), 36-inch pipe referenced, invert elevation 9 feet below the crown]. FS Date: 8/27/2013

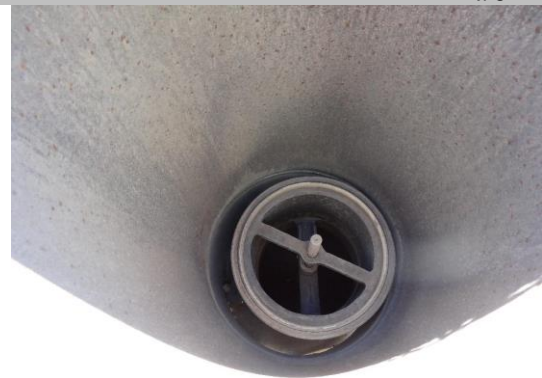
Photo 2 of 3 : UCIP_SP_2018_20727_34888.jpg

WS view: siphon breaker in pipe riser on levee shoulder.

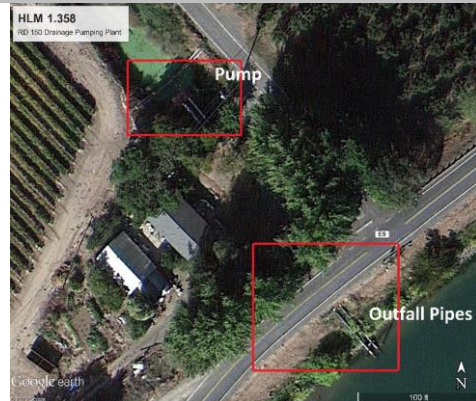
Photo 1 of 3 : UCIP_SP_2018_20346_34350.jpg

Bird's Eye view: pumping plant (top) and outfall pipes (bottom).

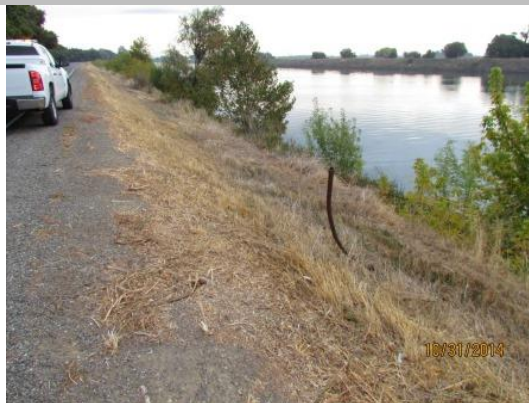
Photo 1 of 1 : SP_2018_RD0150_16_48_20180301_00026.jpg

LM Start	1.73	Rating **	M	Issue No.	48
LM End	1.73	Issue Type +	En	Location *	WS
Category	Earthen Levee			GPS Latitude/Longitude	
				Start	End
Item	Encroachments			38.345583 °	38.345583 °
				-121.554507 °	-121.554507 °
DWR ID	DWR_RD0150_02_f_2014_48				
Comment Code					
PO : Pole					
Inspector Comment					
A pole was found on the waterside slope of the levee. Most probably is connected to a pump.

A pole/pipe was found on the waterside slope of the levee looking upstream.

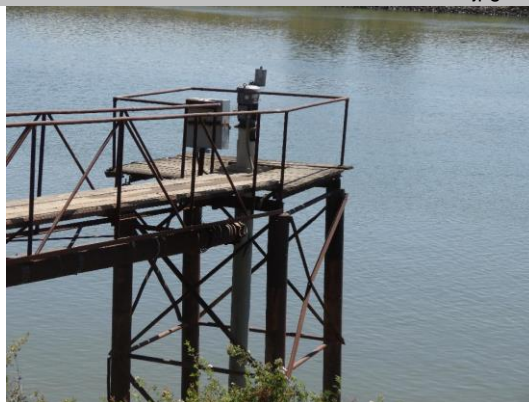
Photo 2 of 3 : UCIP_SP_2018_20348_34370.jpg

WS view: pipe & pump on piling structure in the stream.

Comment Code						
Inspector Comment						
FS_ID:20348						
DS_ID:22395						
EP_NO: N/A						
Repair Type: Non-Urgent						
Crossing Status: Found						
UCIP Comments: - Operating during inspection.- Overhead powerline crossing- CMP riser with siphon breaker needs cleaning.						
FIELD_STRUCT_DESC: 12-inch steel irrigation discharge pipe through the levee, invert elevation 4 feet below the crown. Pump on a piling structure in the river. Power poles on both slopes. Ramp on the landside (LS) slope. Siphon breaker on the LS shoulder. [Additional Reference(s): DWR Levee Log, 2005. USACE Sacramento O&M Manual 112, March 1957, (RM 35.94)].						
FS Date: 8/27/2013

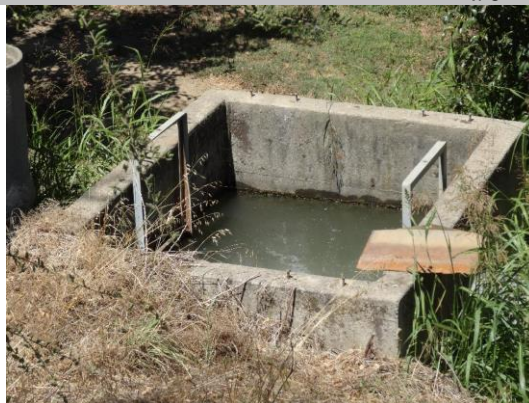
Photo 3 of 3 : UCIP_SP_2018_20348_34369.jpg

LS view: concrete distribution box on levee toe.

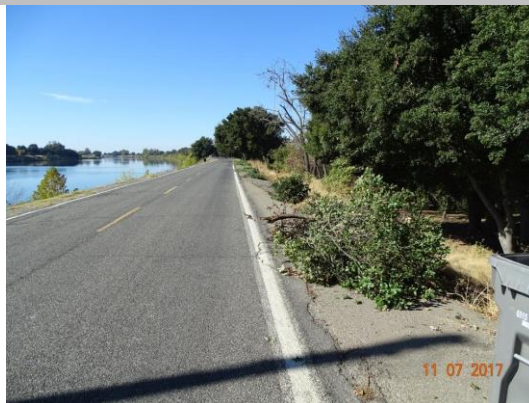
Photo 1 of 1 : SP_2018_RD0150_16_68_20180301_00049.jpg

LM Start	2.14	Rating **	M	Issue No.	68
LM End	2.14	Issue Type +	Ma	Location *	LS
Category	Earthen Levee			GPS Latitude/Longitude	
				Start	End
Item	Encroachments			38.347083 °	38.347083 °
				-121.547063 °	-121.547063 °
DWR ID	DWR_RD0150_02_f_2017_68				
Comment Code					
PR : Prunings					
Inspector Comment

View of prunings on the landside shoulder of the levee.

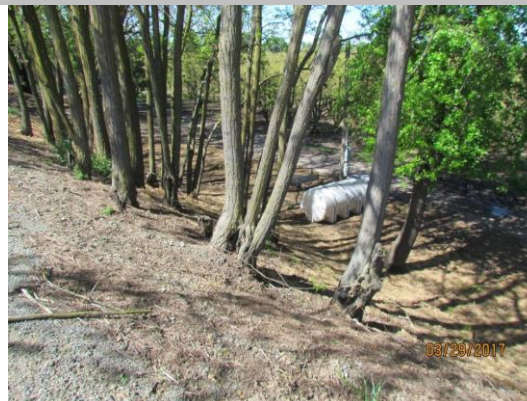
Photo 1 of 1 : SP_2018_RD0150_16_70_20180301_00050.jpg

LM Start	2.72	Rating **	M	Issue No.	70
LM End	2.72	Issue Type +	En	Location *	LS
Category	Earthen Levee			GPS Latitude/Longitude	
				Start	End
Item	Encroachments			38.349777 °	38.349777 °
				-121.537247 °	-121.537247 °
DWR ID	DWR_RD0150_02_s_2017_70				
Comment Code					
TA : Tank					
Inspector Comment

A tank was found on the landside toe of the levee.

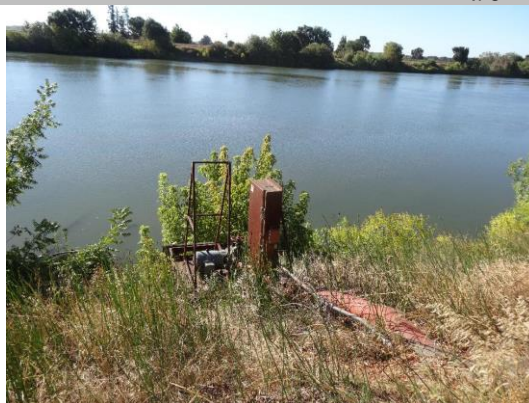
Photo 1 of 3 : UCIP_SP_2018_20736_34917.jpg

Comment Code						
Inspector Comment						
FS_ID:20736						
DS_ID:22402						
EP_NO: N/A						
Repair Type: Non-Urgent						
Crossing Status: Found						
UCIP Comments: - 10" steel pipe sleeved through 12" steel pipe.- main pipe bifurcates into two pipes on LS slope and connected to standpipe and concrete box.- 2" electric conduit on WS and power pole on LS.- needs filling into gap between 10" and 12" steel pipes on LS.						
FIELD_STRUCT_DESC: 12-inch steel irrigation discharge pipe through the levee, invert elevation 4 feet below the crown. Pump on a piling structure in the river. Concrete standpipe and concrete distribution box at the landside (LS) toe. (A. Green). [Additional Reference(s): DWR Levee Log, 2005. USACE Sacramento O&M Manual 112, March 1957, (RM 37.30)].						
FS Date: 8/30/2013

WS view: pipe, conduit and pump on levee slope.

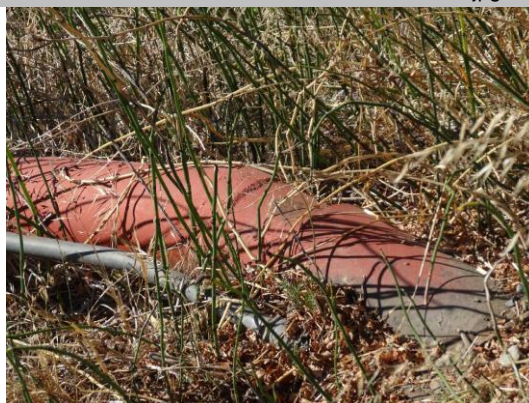
Photo 2 of 3 : UCIP_SP_2018_20736_34916.jpg

WS view: steel pipe and GI conduit on levee slope.

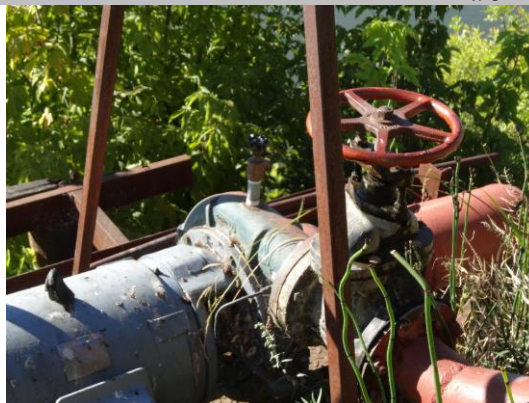
Photo 3 of 3 : UCIP_SP_2018_20736_34915.jpg

Comment Code						
Inspector Comment						
FS_ID:20736 DS_ID:22402 EP_NO: N/A Repair Type: Non-Urgent Crossing Status: Found UCIP Comments: - 10" steel pipe sleeved through 12" steel pipe.- main pipe bifurcates into two pipes on LS slope and connected to standpipe and concrete box.- 2" electric conduit on WS and power pole on LS.- needs filling into gap between 10" and 12" steel pipes on LS. FIELD_STRUCT_DESC: 12-inch steel irrigation discharge pipe through the levee, invert elevation 4 feet below the crown. Pump on a piling structure in the river. Concrete standpipe and concrete distribution box at the landside (LS) toe. (A. Green). [Additional Reference(s): DWR Levee Log, 2005. USACE Sacramento O&M Manual 112, March 1957, (RM 37.30)]. FS Date: 8/30/2013

WS view: pipe and pump on levee slope. Gate valve and air vent on the pipe.

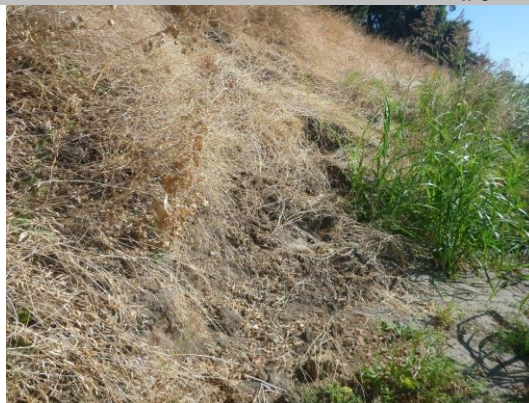
Photo 1 of 3 : LEVAL_SP_2018_287_2143.jpg

LM Start	3.42	Rating **	A/W	Issue No.	47
LM End	3.46	Issue Type +	Ma	Location *	
Category	Supplemental			GPS Latitude/Longitude	
				Start	End
Item	2017 Storm Damage			38.357183 °	38.357631 °
				-121.528547 °	-121.527981 °
DWR ID	DWR_RD0150_02_f _ 2017_47				
Comment Code					
Inspector Comment					
Levee Evaluation Comments					
Description:The flood damage consists of a waterside erosion approximately 229 feet long on the west (right) bank of the Sacramento River. See attached pages for photos.					
Site ID No:287					
Site Designation:LMA-113					
Repair Type: Erosion					
Rating:Serious					
Field Date:7/17/2017					
Notes: Crown is a paved road. Erosion scarps upto 10 ft deep and within 5 ft of crown. Worst conditions on the DS end. Exposed filter fabric. Serious because of depth of erosion into levee, weak soil, and proximity to crown which is a high traffic public road.

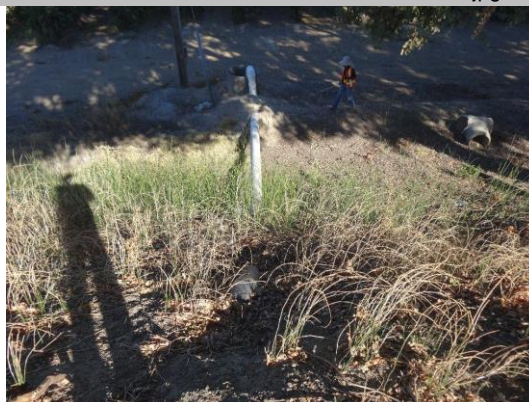
Photo 3 of 3 : UCIP_SP_2018_19846_33725.jpg

LS view: exposed pipe on levee slope and standpipe on the toe.

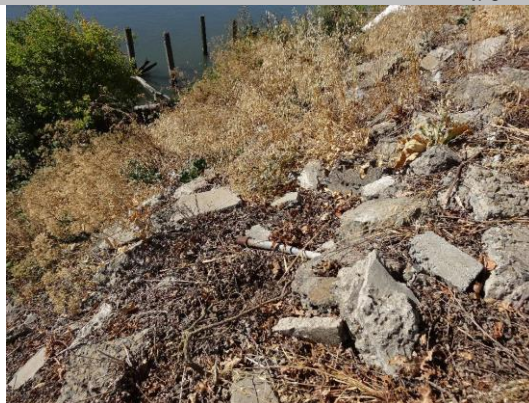
Photo 1 of 3 : UCIP_SP_2018_19848_33734.jpg

LM Start	3.51	Rating **	M	Issue No.	1002
LM End	3.51	Issue Type +	En	Location *	
Category	Supplemental			GPS Latitude/Longitude	
				Start	End
Item	DWR UCIP Field Study			38.358131 °	38.358131 °
				-121.527540 °	-121.527540 °
DWR ID					
Comment Code					
Inspector Comment					
FS_ID:19848 DS_ID:22404 EP_NO: N/A Repair Type: Non-Urgent Crossing Status: Found UCIP Comments: - needs proper abandonment. FIELD_STRUCT_DESC: *ABANDONED* 4-inch steel pipe of an unknown purpose on the landside (LS) slope. 1-inch steel conduit on the waterside (WS) slope was found. FS Date: 8/30/2013

WS view: abandoned 1-inch conduit on levee slope.

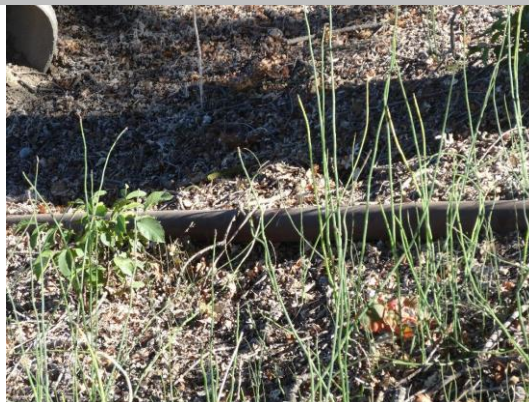
Photo 2 of 3 : UCIP_SP_2018_19848_33733.jpg

LS view: exposed 4-inch steel pipe on levee slope.

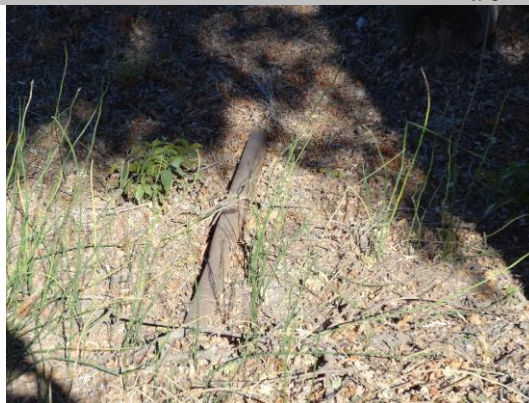
Photo 3 of 3 : UCIP_SP_2018_19848_33732.jpg

LS view: abandoned 4-inch steel pipe on levee slope.

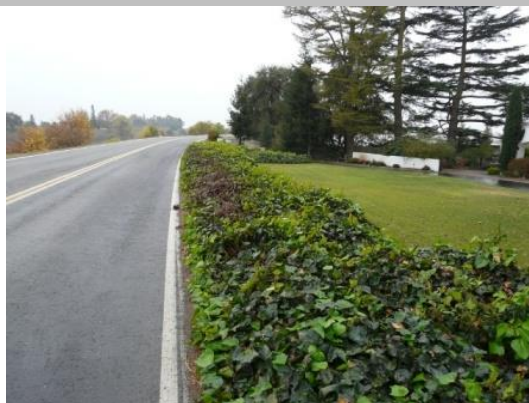
Photo 1 of 1 : SP_2018_RD0150_16_80_20180301_00054.jpg

LM Start	3.84	Rating **	U	Issue No.	80
LM End	3.87	Issue Type +	En	Location *	LS
Category	Earthen Levee			GPS Latitude/Longitude	
				Start	End
Item	Vegetation			38.361442 °	38.361812 °
				-121.523170 °	-121.522908 °
DWR ID	DWR_RD0150_02_s_2012_80				
Comment Code					
V6 : Landscaping					
Inspector Comment

Landscaping in front of a residence on landside of levee from LM 3.90 to LM 3.93. The levee in this location is greater than 100' wide.

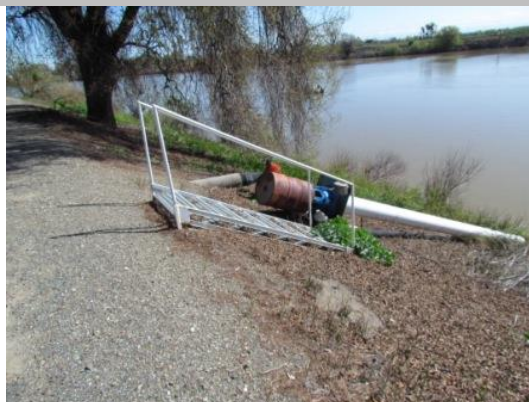
Photo 1 of 1 : SP_2018_RD0150_16_33_20180301_00016.jpg

LM Start	3.88	Rating **	M	Issue No.	33
LM End	3.88	Issue Type +	En	Location *	WS
Category	Earthen Levee			GPS Latitude/Longitude	
				Start	End
Item	Encroachments			38.361970 °	38.361970 °
				-121.522777 °	-121.522777 °
DWR ID	DWR_RD0150_02_s_2012_33				
Comment Code					
ST : Stairway					
Inspector Comment

A stairway was found on the waterside slope of the levee.

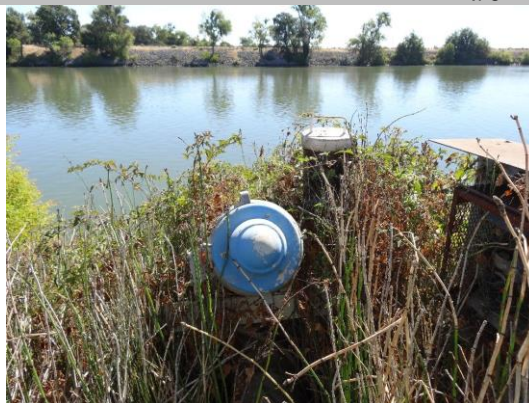
Photo 1 of 3 : UCIP_SP_2018_42702_33782.jpg

Comment Code						
Inspector Comment						
FS_ID:42702 DS_ID:22407 EP_NO: 13505 Repair Type: Non-Urgent Crossing Status: Found UCIP Comments: Appears abandoned and if so should be done so properly.- no pipe and structure found on landside.- siphon breaker in 24" CMP riser on waterside.- control box and electric conduit on waterside slope. FIELD_STRUCT_DESC: 14-inch steel irrigation discharge pipe through the levee, invert elevation 5 feet below the crown. Slant pump on the waterside (WS) slope. Siphon breaker on the WS slope in a corrugated metal pipe (CMP) riser. Control box and electrical conduit on the WS slope. (Plans to replace an existing pipeline with a 14-inch steel pipeline through the levee authorized under Permit No. 13505, 1982 - Gary Pylman). [Additional Reference(s): DWR Levee Log, 2005, 10-inch pipe referenced. USACE Sacramento O&M Manual 112, March 1957, (RM 38.24), 10-inch pipe referenced]. FS Date: 8/30/2013

WS view: slanted pump on levee slope.

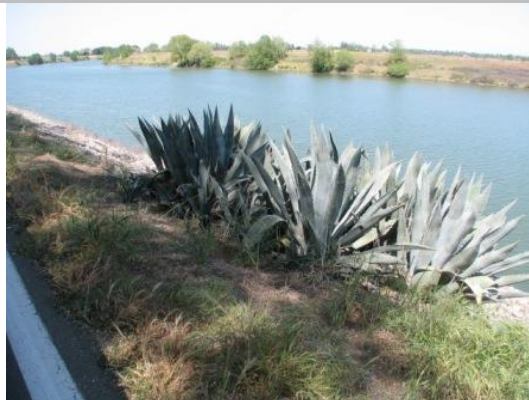
Photo 1 of 1 : SP_2018_RD0150_16_28_20180301_00013.jpg

LM Start	4.69	Rating **	M	Issue No.	28
LM End	4.69	Issue Type +	Ma	Location *	WS
Category	Earthen Levee			GPS Latitude/Longitude	
				Start	End
Item	Vegetation			38.373485 °	38.373485 °
				-121.523963 °	-121.523963 °
DWR ID	DWR_RD0150_02_s_2012_28				
Comment Code					
V2 : Remove the wild growth other than native grasses from the levee slopes.					
Inspector Comment

Century plant on waterward slope at LM 4.76

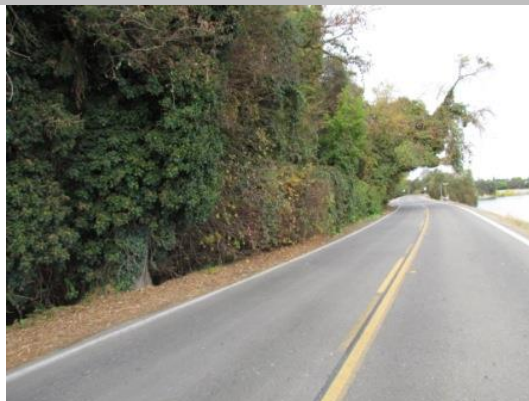
Photo 1 of 1 : SP_2018_RD0150_16_76_20180301_00052.jpg

LM Start	4.70	Rating **	U	Issue No.	76
LM End	4.72	Issue Type +	En	Location *	LS
Category	Earthen Levee			GPS Latitude/Longitude	
				Start	End
Item	Vegetation			38.373688 °	38.373970 °
				-121.524280 °	-121.524403 °
DWR ID	DWR_RD0150_02_s_2012_76				
Comment Code					
V6 : Landscaping					
Inspector Comment

Trees were obstructing the view of the landside slope of the levee looking upstream.

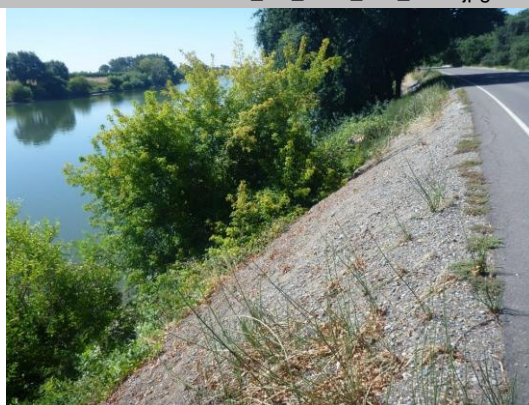
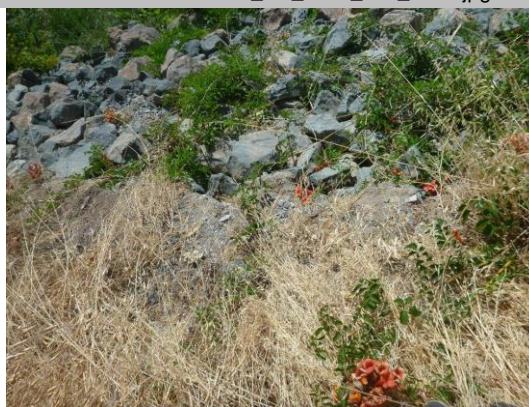
LM Start	5.04	Rating **	A/W	Issue No.	50
LM End	5.12	Issue Type +	Ma	Location *	
Category	Supplemental			GPS Latitude/Longitude	
				Start	End
Item	2017 Storm Damage			38.378311 °	38.379458 °
				-121.525317 °	-121.524931 °
DWR ID	DWR_RD0150_02_f _ 2017_50				
Comment Code					
Inspector Comment					
Levee Evaluation Comments					
Description:The flood damage consists of a waterside erosion approximately 447 feet long on the west (right) bank of the Sacramento River. See attached pages for photos.					
Site ID No:288					
Site Designation:LMA-114					
Repair Type: Erosion					
Rating:Area of Concern					
Field Date:7/17/2017					
Notes: Crown is a paved road. Much of site was not accessible because of thorny veg. Scarps were only about 1 ft deep where it was accessible so rated it a lower priorit. Irrigation pipe within the site. A boat view would be helpful here.

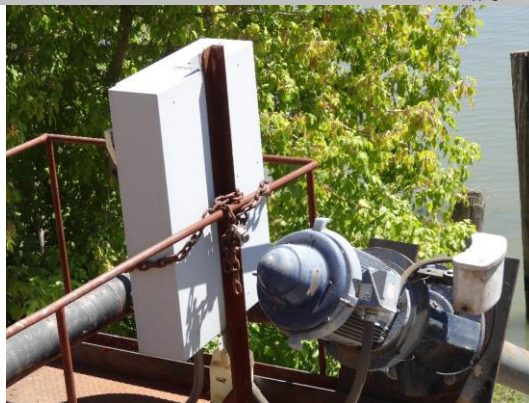
Photo 2 of 3 : UCIP_SP_2018_20740_34940.jpg

WS view: pipe, slant pump & pump platform on stream bank.

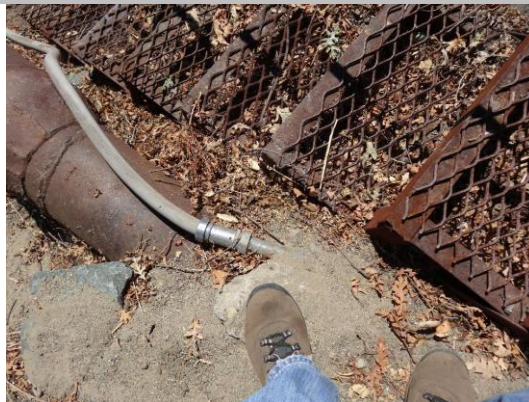
Photo 3 of 3 : UCIP_SP_2018_20740_34939.jpg

WS view: steel steps to pump platform, exposed steel pipe, and electric conduit on levee slope.

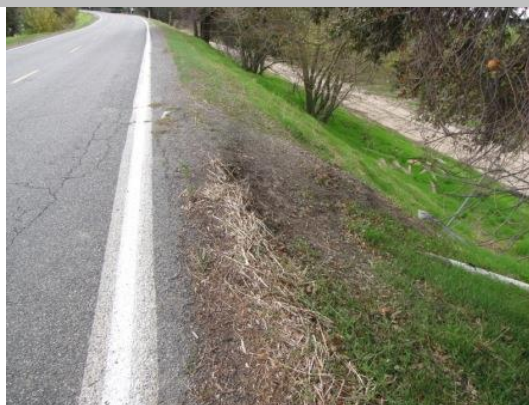
Photo 2 of 2 : SP_2018_RD0150_16_975_20180301_00067.jpg

LM Start	5.24	Rating **	M	Issue No.	975
LM End	5.24	Issue Type +	Ma	Location *	WS
Category	Earthen Levee			GPS Latitude/Longitude	
				Start	End
Item	Slope Stability			38.381126 °	38.381126 °
				-121.524207 °	-121.524207 °
DWR ID	DWR_RD0150_02_s_2013_975				
Comment Code					
S1 : Repair slope instability.					
Inspector Comment					
Depression in the waterward slope at the shoulder over an irrigation pipe.

View of a minor depression along the landward slope of the levee over a pipe penetration looking downstream.

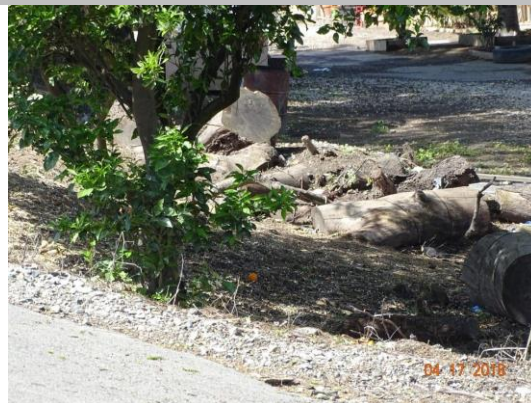
Photo 1 of 1 : SP_2018_RD0150_16_86_20180417_00128.jpg

LM Start	5.44	Rating **	U	Issue No.	86	
LM End	5.44	Issue Type +	En	Location *	LS	
Category	Earthen Levee			GPS Latitude/Longitude		
				Start		End
Item	Encroachments			38.383127 °		38.383127 °
				-121.521603 °		-121.521603 °
DWR ID	DWR_RD0150_02_s_2018_86					
Comment Code						
FW : Firewood						
Inspector Comment						
Firewood at landside toe.

Encroachment firewood landside looking west.

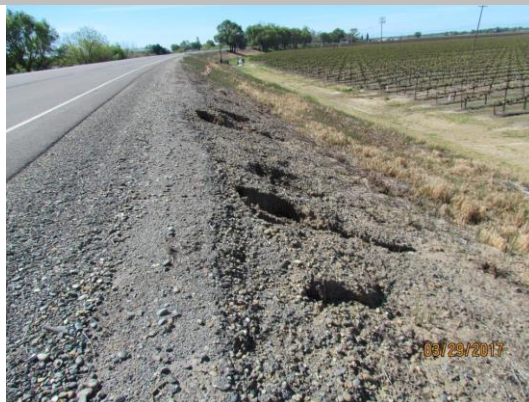
Photo 1 of 2 : SP_2018_RD0150_16_52_20180301_00031.jpg

LM Start	5.90	Rating **	M	Issue No.	52
LM End	5.90	Issue Type +	Ma	Location *	LS
Category	Earthen Levee		GPS Latitude/Longitude		
			Start	End	
Item	Erosion / Bank Caving		38.387915 °	38.387915 °	
			-121.516002 °	-121.516002 °	
DWR ID	DWR_RD0150_02_f_2016_52				
Comment Code					
E2 : Schedule repair of erosion site prior to the next inspection.					
Inspector Comment					
Erosion due to runoff.

Updated picture of the erosion on the landside of the levee during spring 2017 inspection.

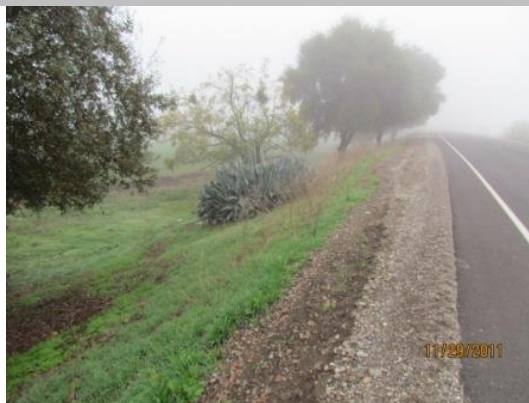
Photo 1 of 1 : SP_2018_RD0150_16_27_20180301_00012.jpg

LM Start	6.30	Rating **	M	Issue No.	27
LM End	6.30	Issue Type +	En	Location *	LS
Category	Earthen Levee			GPS Latitude/Longitude	
				Start	End
Item	Vegetation			38.393655 °	38.393655 °
				-121.514654 °	-121.514654 °
DWR ID	DWR_RD0150_02_s _ 2012_27				
Comment Code					
V6 : Landscaping					
Inspector Comment					
Century plant on the landward slope.

Century plant was found on the landside of the levee looking upstream.

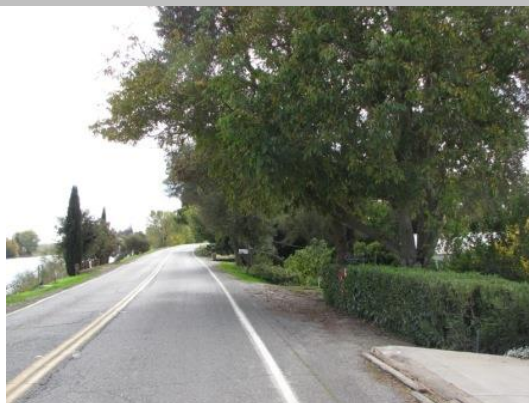
Photo 1 of 1 : SP_2018_RD0150_16_65_20180301_00046.jpg

LM Start	6.39	Rating **	M	Issue No.	65
LM End	6.46	Issue Type +	En	Location *	LS
Category	Earthen Levee			GPS Latitude/Longitude	
				Start	End
Item	Vegetation			38.394935 °	38.395931 °
				-121.514597 °	-121.514604 °
DWR ID	DWR_RD0150_02_s_2012_65				
Comment Code					
V6 : Landscaping					
Inspector Comment

View of landscaping along the waterward shoulder and slope looking downstream.

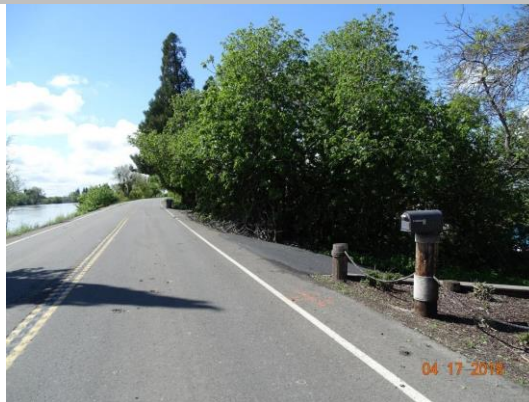
Photo 1 of 1 : SP_2018_RD0150_16_78_20180430_00134.jpg

LM Start	6.40	Rating **	U	Issue No.	78
LM End	6.42	Issue Type +	En	Location *	LS
Category	Earthen Levee			GPS Latitude/Longitude	
				Start	End
Item	Vegetation			38.394977 °	38.395325 °
				-121.514544 °	-121.514563 °
DWR ID	DWR_RD0150_02_s_2018_78				
Comment Code					
V6 : Landscaping					
Inspector Comment

Vegetation landside looking south.

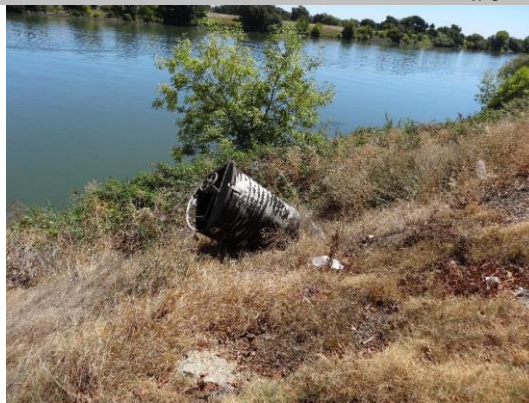
Photo 3 of 3 : UCIP_SP_2018_50669_34983.jpg

Comment Code						
Inspector Comment						
FS_ID:50669 DS_ID:22413 EP_NO: N/A Repair Type: Non-Urgent Crossing Status: Found UCIP Comments: 11/09/2016 Per FPIIB Inspector Pavel Kazi, the CMP riser has been removed and the pipe is now exposed. Pipe still requires proper abandonment. (K. Fazel - UCIP)08/30/2013 Only an abandoned and dismantled CMP riser with gate valve found on WS levee slope. May need proper abandonment. (P. Amatya - DWR) FIELD_STRUCT_DESC: *ABANDONED* 6-inch steel irrigation discharge pipe, 10 feet below the crown. Gate valve on each end, though only one was found on the waterside (WS) in 2013. Pump on the landside (LS), 10 feet from the LS toe, not found in 2013. Riser on the WS slope has been removed as of the 2016 inspection. (C. Godfrey). [Additional Reference(s): DWR Levee Log, 2005. USACE Sacramento O&M Manual 112, March 1957, (RM 40.60), referenced as invert elevation 8.5 feet below the crown]. FS Date: 11/9/2016

WS view: an abandoned and dismantled CMP riser with gate valve handle on WS levee slope.

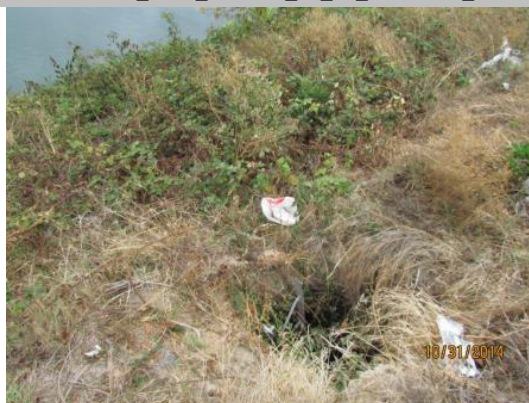
Photo 1 of 1 : SP_2018_RD0150_16_55_20180301_00037.jpg

LM Start	6.50	Rating **	U	Issue No.	55
LM End	6.50	Issue Type +	En	Location *	WS
Category	Earthen Levee			GPS Latitude/Longitude	
				Start	End
Item	Encroachments			38.396518 °	38.396518 °
				-121.514530 °	-121.514530 °
DWR ID	DWR_RD0150_02_f_2014_55				
Comment Code					
PI : Pipe					
Inspector Comment					
The pipe gate needs to be covered on the waterside toe of the levee.

An open pipe valve was found without a cover on the waterside toe of the levee.

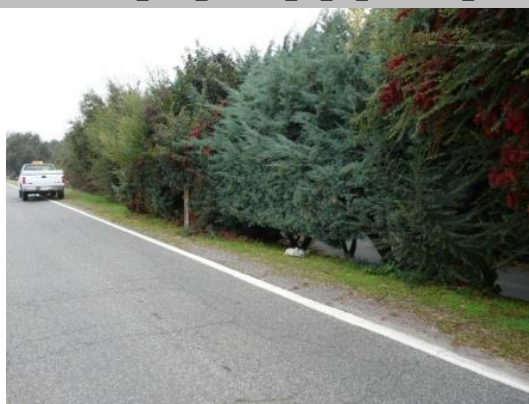
Photo 1 of 1 : SP_2018_RD0150_16_64_20180301_00045.jpg

LM Start	6.57	Rating **	U	Issue No.	64
LM End	6.61	Issue Type +	En	Location *	LS
Category	Earthen Levee			GPS Latitude/Longitude	
				Start	End
Item	Vegetation			38.397523 °	38.398000 °
				-121.514658 °	-121.514731 °
DWR ID	DWR_RD0150_02_s_2012_64				
Comment Code					
V6 : Landscaping					
Inspector Comment

Landscaping providing a screen for a residence on landside of levee from LM 6.68 to LM 6.72

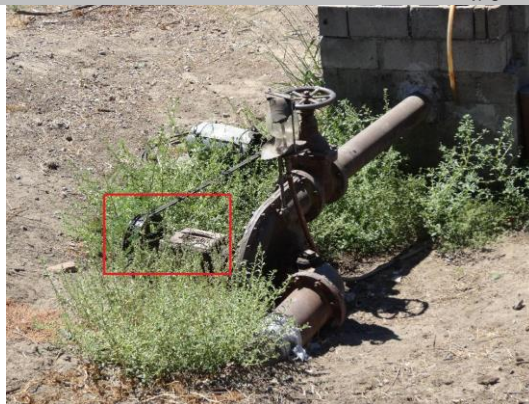
Photo 3 of 3 : UCIP_SP_2018_41646_34100.jpg

LS view: concrete masonry distribution box (top), steel pipe, gate valve, air vent, and pump (left) on levee toe.

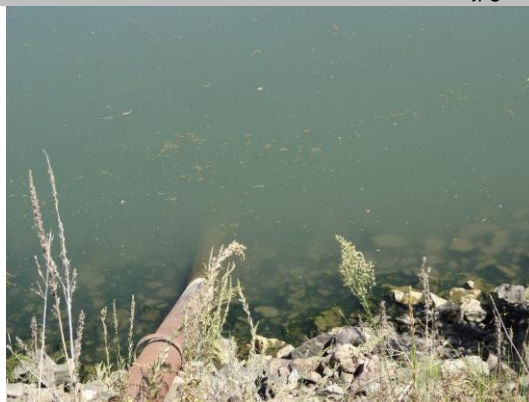
Photo 2 of 3 : UCIP_SP_2018_50387_35001.jpg

WS view: steel inlet pipe in the stream and bank.

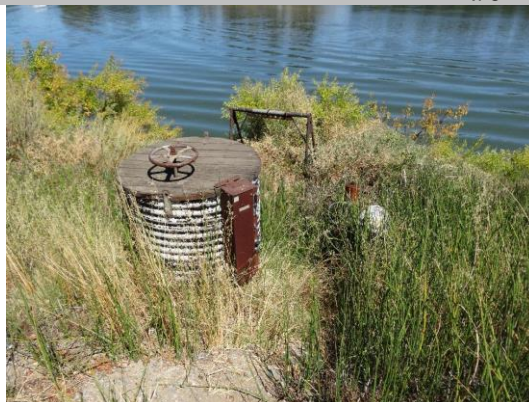
Photo 1 of 3 : UCIP_SP_2018_50386_34162.jpg

Comment Code						
Inspector Comment						
FS_ID:50386 DS_ID:22429 EP_NO: N/A Repair Type: Urgent Crossing Status: Found UCIP Comments: - soil erosion along pipe alignment on LS slope.- needs more investigation and mitigation for soil erosion. FIELD_STRUCT_DESC: 8-inch concrete encased steel irrigation discharge pipe through the levee, 10 feet below the crown. Pump on a concrete slab and a slide gate in a corrugated metal pipe (CMP) riser on the waterside (WS) slope. Pipe through the levee section is encased in reinforced concrete. Concrete standpipe at the landside (LS) toe. (A. Monice). [Additional Reference(s): DWR Levee Log, 2005. USACE Sacramento O&M Manual 112, March 1957, (RM 41.10), referenced as invert elevation 8.2 feet below the crown]. FS Date: 8/30/2013

WS view: CMP riser with slide gate and pump (right) on levee slope.

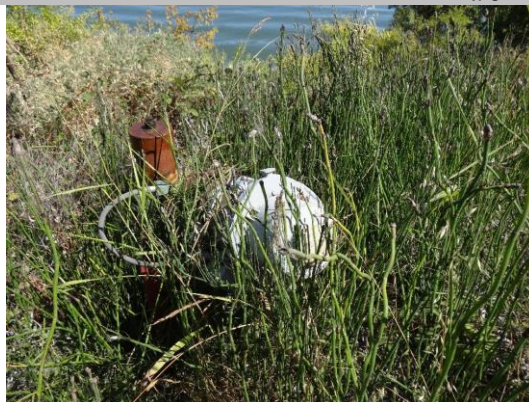
Photo 3 of 3 : UCIP_SP_2018_50386_34160.jpg

WS view: pump on levee slope. Dense vegetation on levee slope.

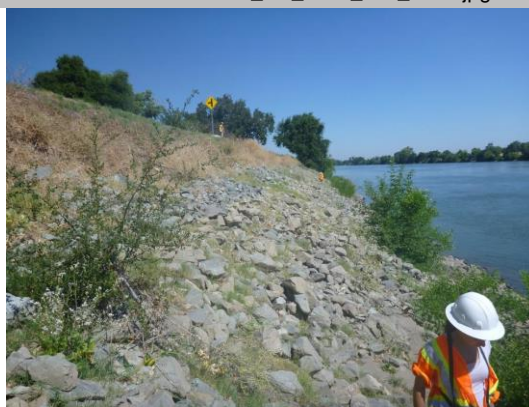
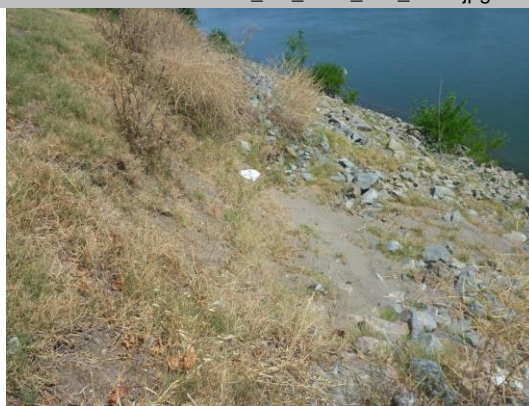
Description: The flood damage consists of a waterside erosion approximately 311 feet long on the west (right) bank of the Sacramento River. See attached pages for photos.

Comment Code					
Inspector Comment					
Levee Evaluation Comments					
Description:The flood damage consists of a waterside erosion approximately 311 feet long on the west (right) bank of the Sacramento River. See attached pages for photos.					
Site ID No:289					
Site Designation:LMA-115					
Repair Type: Erosion					
Rating:Area of Concern					
Field Date:7/17/2017					
Notes: Crown is a paved road. 2 scarps 6 ft deep and about 15 ft long each within site and 6 ft from crown, otherwise erosion was pretty small. Rip rapon 3/4 of slope here, but not full coverage. Area of concern because deeper scarps only extended a short distance.

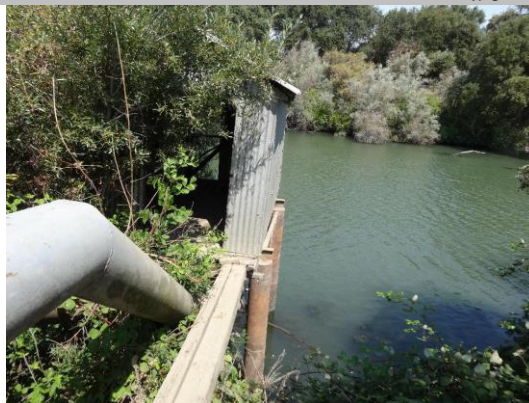
Photo 3 of 3 : UCIP_SP_2018_19112_32042.jpg

LM Start	1.35	Rating **	M	Issue No.	953 (cont)	
LM End	1.35	Issue Type +	En	Location *		
Category	Supplemental			GPS Latitude/Longitude		
				Start		End
Item	DWR UCIP Field Study			38.347489 °		38.347489 °
				-121.573302 °		-121.573302 °
DWR ID						
Comment Code						
Inspector Comment						
FS_ID:19112 DS_ID:22433 EP_NO: N/A Repair Type: Non-Urgent Crossing Status: Found UCIP Comments: No handrail on wooden walkway. FIELD_STRUCT_DESC: 14-inch steel irrigation discharge pipe through the levee, invert elevation 8 feet below the crown. Pump in a pump house on the waterside (WS) slope. Service pole and steel distribution box on the landside (LS) slope. (A. Pylman). [Additional Reference(s): DWR Levee Log, 2005. USACE Sacramento O&M Manual 112, March 1957, (HLM 1.39)]. FS Date: 8/20/2013

WS view: pipe, wooden walkway and pump house in channel.

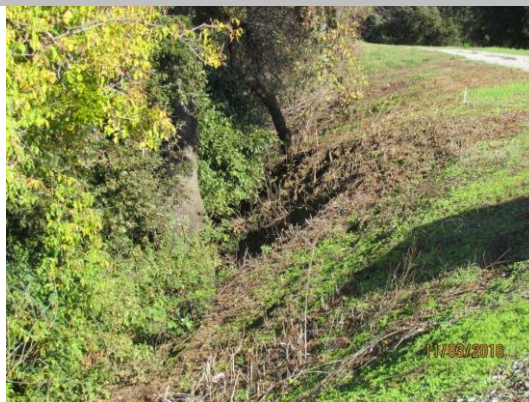
Photo 1 of 1 : SP_2018_RD0150_17_70_20180301_00067.jpg

LM Start	1.42	Rating **	A/W	Issue No.	70
LM End	1.42	Issue Type +	Ob	Location *	WS
Category	Earthen Levee			GPS Latitude/Longitude	
				Start	End
Item	Erosion / Bank Caving			38.348132 °	38.348132 °
				-121.572368 °	-121.572368 °
DWR ID	DWR_RD0150_03_f_2016_70				
Comment Code					
E1 : Note and monitor erosion site.					
Inspector Comment

View of an erosion on the waterside slope of the levee. Fall 2016

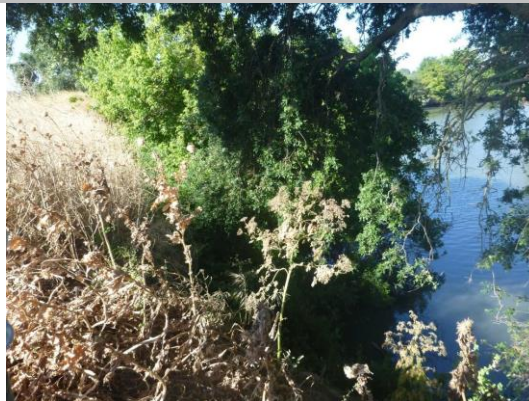
Photo 2 of 3 : LEVAL_SP_2018_293_2194.jpg

LM Start	1.42	Rating **	A/W	Issue No.	33
LM End	1.44	Issue Type +	Ma	Location *	
Category	Supplemental			GPS Latitude/Longitude	
				Start	End
Item	2017 Storm Damage			38.348142°	38.348411°
				-121.572319°	-121.572339°
DWR ID	DWR_RD0150_03_f_2017_33				
Comment Code

Description: Instability, cracking, and erosion were observed on the waterside levee slope on the east (left) bank of Elk Slough. The site is approximately 98 feet long. See attached pages for photos.

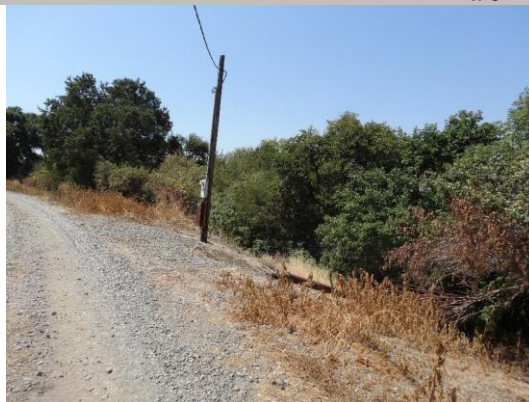
Photo 1 of 3 : UCIP_SP_2018_19137_32108.jpg

LM Start	1.78	Rating **	M	Issue No.	954
LM End	1.78	Issue Type +	En	Location *	
Category	Supplemental		GPS Latitude/Longitude		
			Start	End	
Item	DWR UCIP Field Study		38.353180 °	38.353180 °	
			-121.572907 °	-121.572907 °	
DWR ID					
Comment Code					
Inspector Comment					
FS_ID:19137					
DS_ID:22434					
EP_NO: N/A					
Repair Type: Non-Urgent					
Crossing Status: Found					
UCIP Comments: Small depression on WS slope due to leak from pump. Pipe opens on LS ditch/depression.					
FIELD_STRUCT_DESC: 10-inch steel irrigation discharge pipe through the levee, invert elevation 3.4 feet below the crown. Pump, gate valve, and service pole on the waterside (WS) slope. (W. Bogle). [Additional Reference(s): DWR Levee Log, 2005. USACE Sacramento O&M Manual 112, March 1957, (HLM 1.82), 7-inch pipe referenced].					
FS Date: 8/20/2013

WS view: exposed pipe and power pole on levee slope.

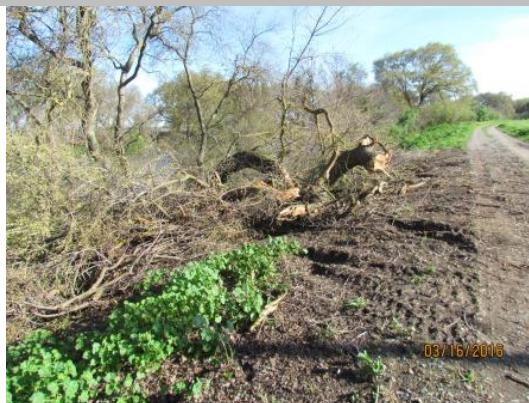
Photo 1 of 1 : SP_2018_RD0150_17_85_20180301_00085.jpg

LM Start	1.83	Rating **	M	Issue No.	85	
LM End	1.83	Issue Type +	Ma	Location *	WS	
Category	Earthen Levee			GPS Latitude/Longitude		
				Start		End
Item	Encroachments			38.353761 °		38.353761 °
				-121.572390 °		-121.572390 °
DWR ID	DWR_RD0150_03_s_2016_85					
Comment Code						
TR : Tree or limb						
Inspector Comment

View of broken tree trunk on the waterside slope of the levee.
